Manhole Inspection Summary

Manhole # S43CC_039MH

Insp Date: **12/18/07 10:11 AM**

Location Address: **n.bond st**

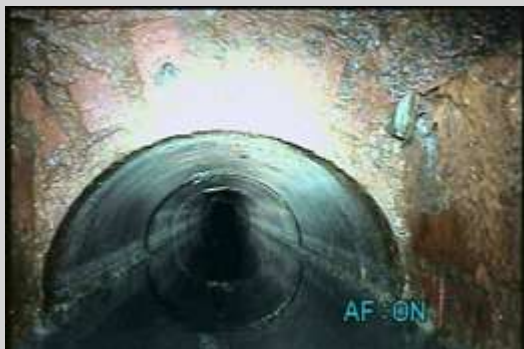
6 O'Clock Inflow

15 in. Circular Gravity Sewer
Pipe In @ 6 O'Clock

Pipe Height: 0 (in.) Direct

Pipe Material: **Clay** ☐ Pipe Lined

Infiltration: **None** Pipe Seal Cond: **Unknown**
